City of St. Augustine

Tree Inventory and Risk Assessment Report

by
Chuck Lippi

City of St. Augustine
Tree Inventory and Risk Assessment Report

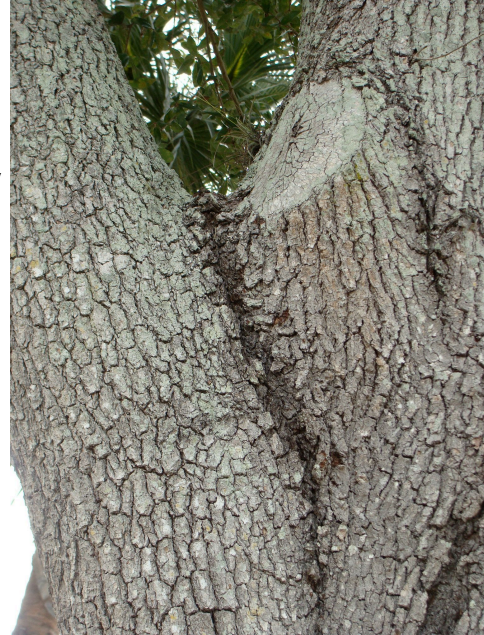
Codominant Leaders -- The main defect observed was codominant leaders. The portion of trees with codominant leaders with included bark is only 19 percent of the total number of trees with codominant leaders (Figure 5). Eighty one percent of the trees with codominant leaders did not have included bark and are less of a hazard (Figure 6). Generally we recommend end weight reduction pruning on codominant leaders especially leaders with included bark.

Figure 5 Two leaders with included bark are shown. These two leaders are more prone to failure by splitting when the tree crown becomes larger and strong wind conditions occur.

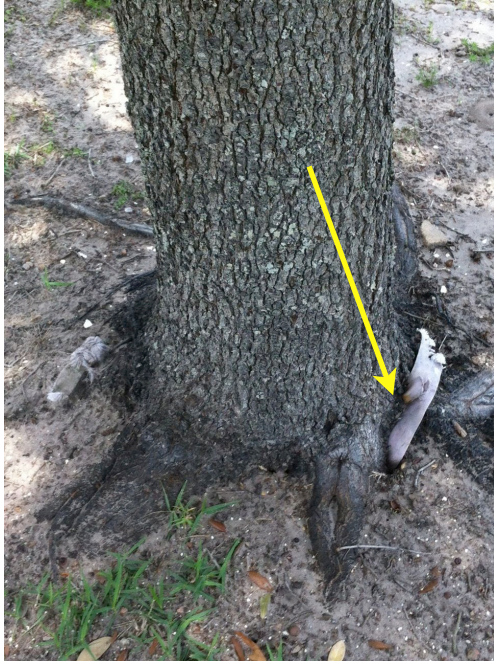
Most of the young trees planted around the William-Gallimore Center showed evidence of improper installation. Nylon installation straps, as well as wire baskets were found in place around the root flare (Figures 11 and 12). The purpose of these materials is to support the root ball during transport and transplanting. Once a tree is planted, these straps and other installation materials should be removed. Leaving them in place can prevent the tree's lateral spread of root growth and girdle the tree. This can lead to multiple problems including shortened life, causing a live oak to die at 20-30 years as opposed to 200 to 300 years. Another problem is stability. Without lateral roots to counter wind loads from significant climatic events, a tree will be more likely to fall. Also health will be severely impaired. As noted in the pictures, many of the specimens are suffering from girdled stems, roots and root flares. Girdling will cut off the vascular tissue beneath the bark layer and can lead to crown dieback (which is already visible in some trees), instability, compromised health, decline even death. Removal of

Figure 11 The wide nylon strap left over from the nursery should have been removed. Now it has been overgrown by the tree and cannot be removed without causing further damage to the tree. The exposed end only should be removed.

installation materials on established trees is not always recommended. In cases such as Figure ___ where much of the strap is exposed, cutting away portions of the strap that have not been grown over is recommended. But if the strap has been overgrown, then it should be left alone. Trying to remove an already overgrown strap will typically cause more harm than good and exacerbate conditions.

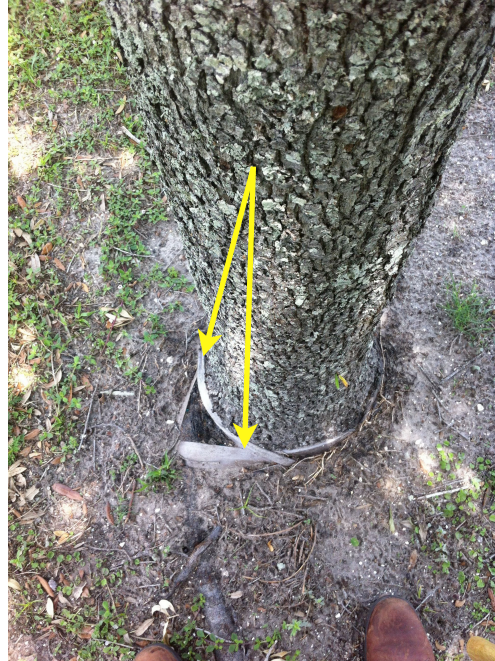
Figure 12 On this tree more of the straps left by the nursery and transplanters are exposed and the exposed sections of strap can be removed without damaging the tree.
