St. Petersburg's

# DESIGN GUIDELINES

for Historic Properties

Adopted; Resolution No. 2017-396, July 13, 2017

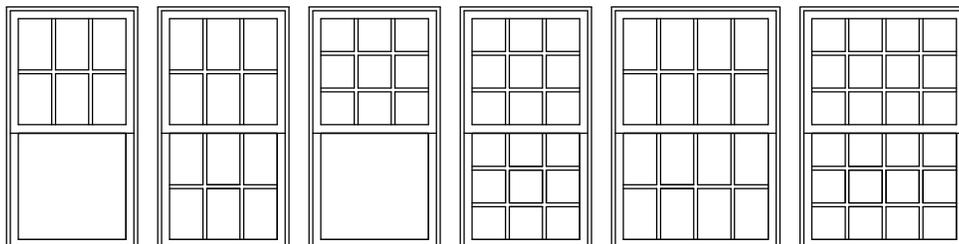
## STANDARD WINDOWS

- Dormer windows are typically multi-paned in the 6 over 6 pattern.
- Special windows are typically small accent windows with 6 panes or in a 4 over 4 muntin pattern.
- Small circular windows, centered on the facade can also be found in this style.

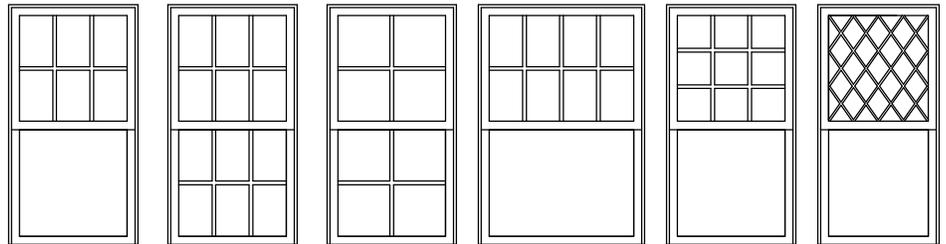
## STANDARD WINDOWS

- Paired or triple windows and dormers are typical
- Dormer windows are typically multi-paned in the 6 over 6 pattern.
- Special windows are typically small accent windows with 6 panes or in a 4 over 4 muntin pattern. Small arched windows, centered on the entry gable or adjacent entry doors can also be found in this style

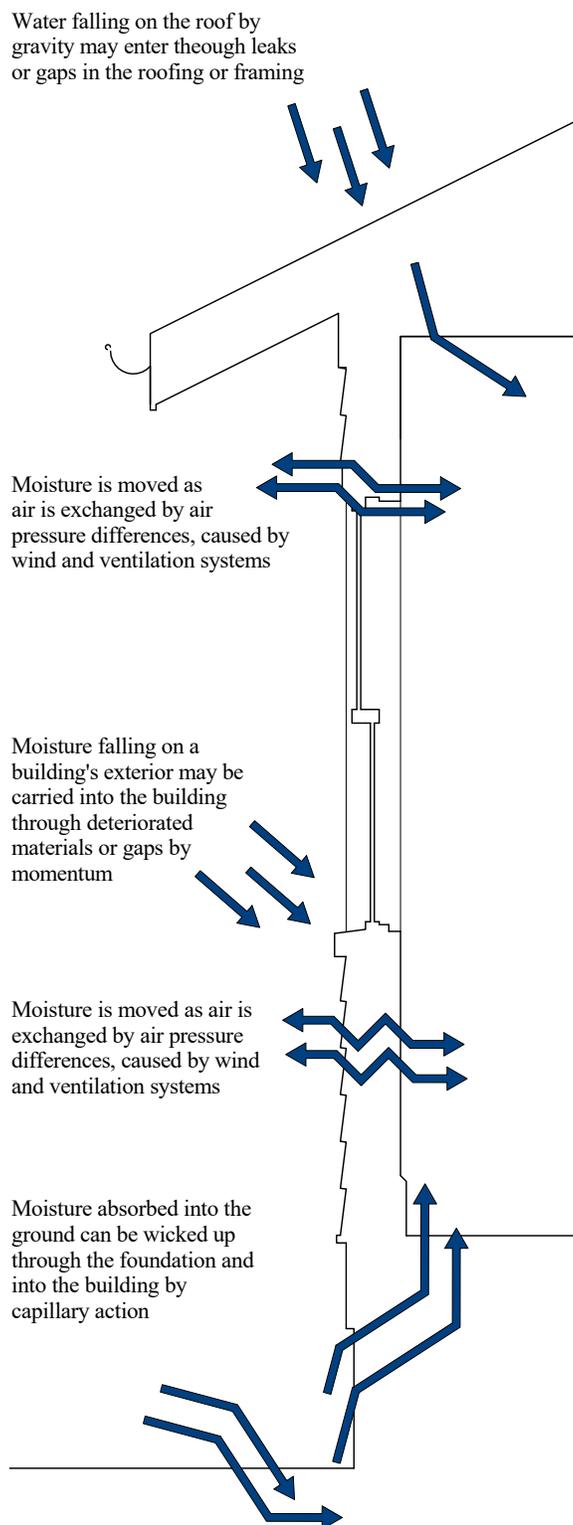
FIGURE 6

- Liquid flow is the movement of bulk moisture (i.e., rain water, ground water, or snow melt) by gravity or momentum.
- Capillarity is the movement of moisture due to surface tension. Spaces between materials or in the chemical composition of a porous material allow moisture to be drawn into a building. On foundations, this is commonly called rising damp because water wicks up through materials as it moves toward the surface to evaporate.
- Air movement is the movement of moisture in vapor form due to air pressure differences in buildings, which typically include wind-induced pressures, stack effect, and pressure differences caused by ventilation systems
- Vapor diffusion is the movement of moisture in vapor form due to vapor pressure differences, which are caused by the same forces as air pressure differences.

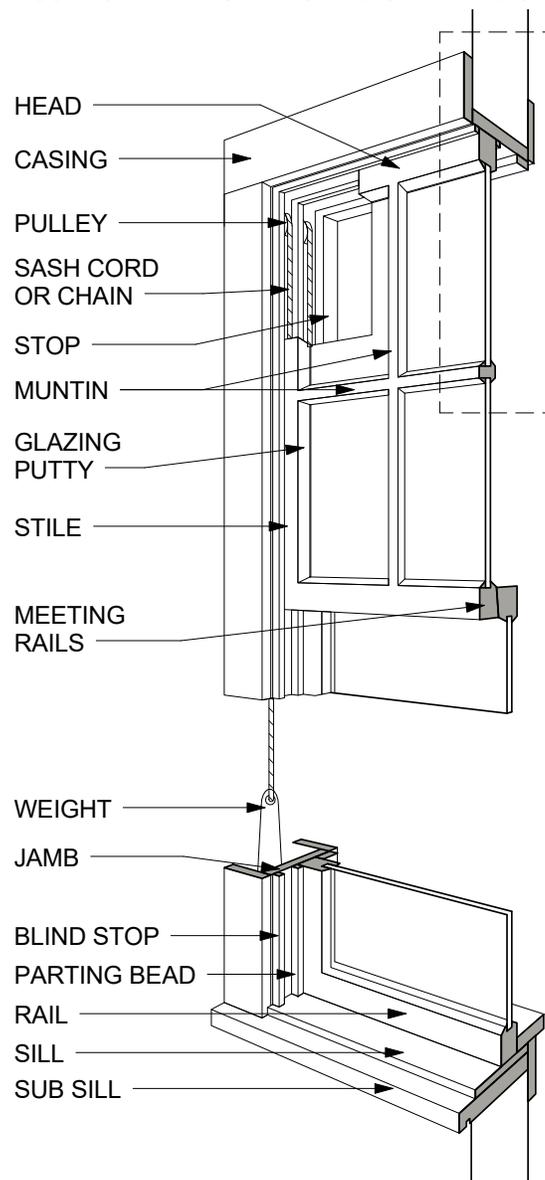
WOOD DOUBLE HUNG WINDOW ILLUSTRATED BELOW

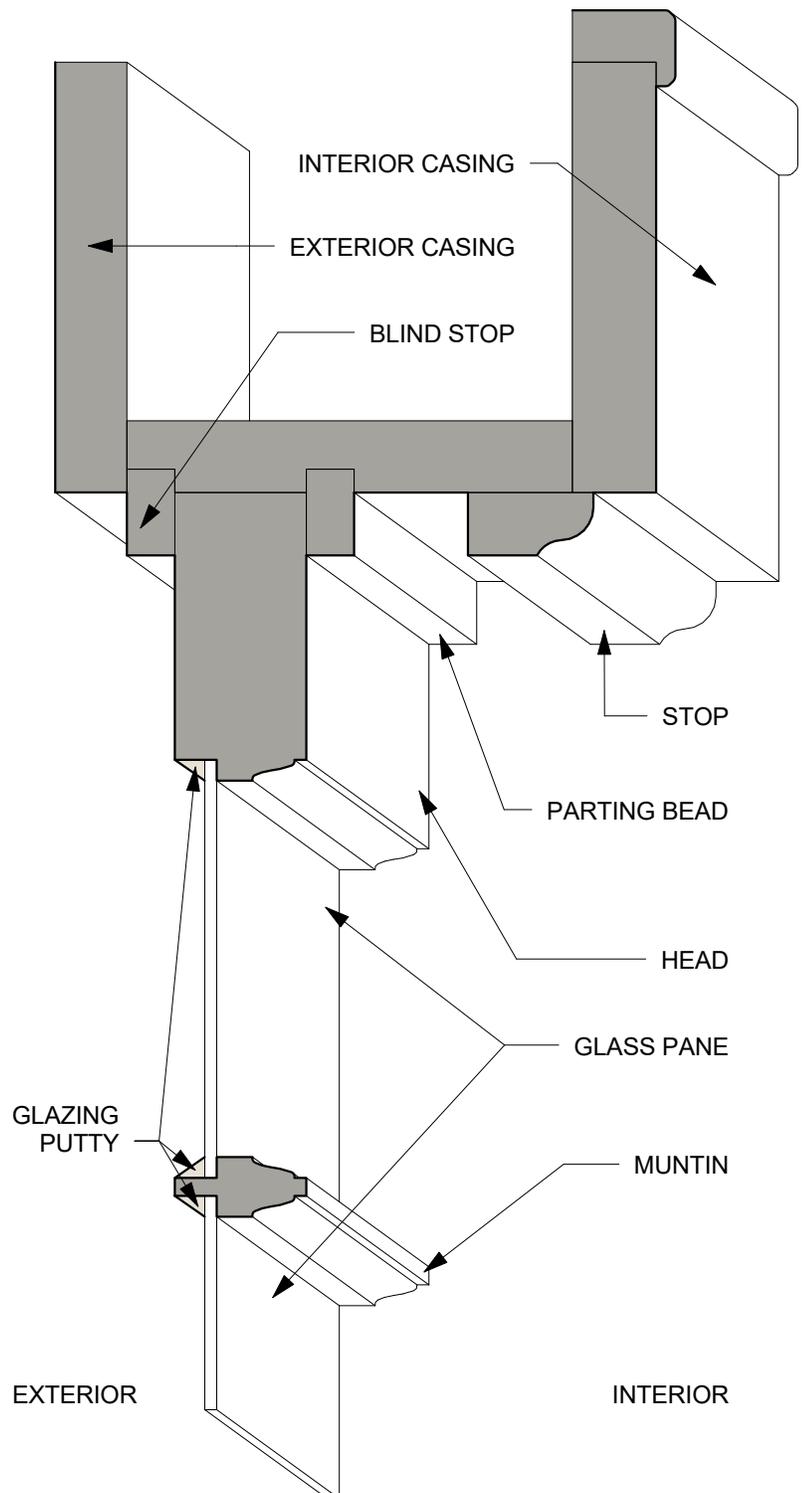
WOOD DOUBLE HUNG WINDOW ILLUSTRATED BELOW

which is naturally stronger and more resistant to deterioration. The repair and weatherization of existing wood windows is more practical than most people realize and many windows are unfortunately replaced because of a lack of awareness of techniques for evaluation, repair, and weatherization. Wood windows which are repaired and properly maintained will have greatly extended service lives while contributing to the historic character of the building and surrounding neighborhood.

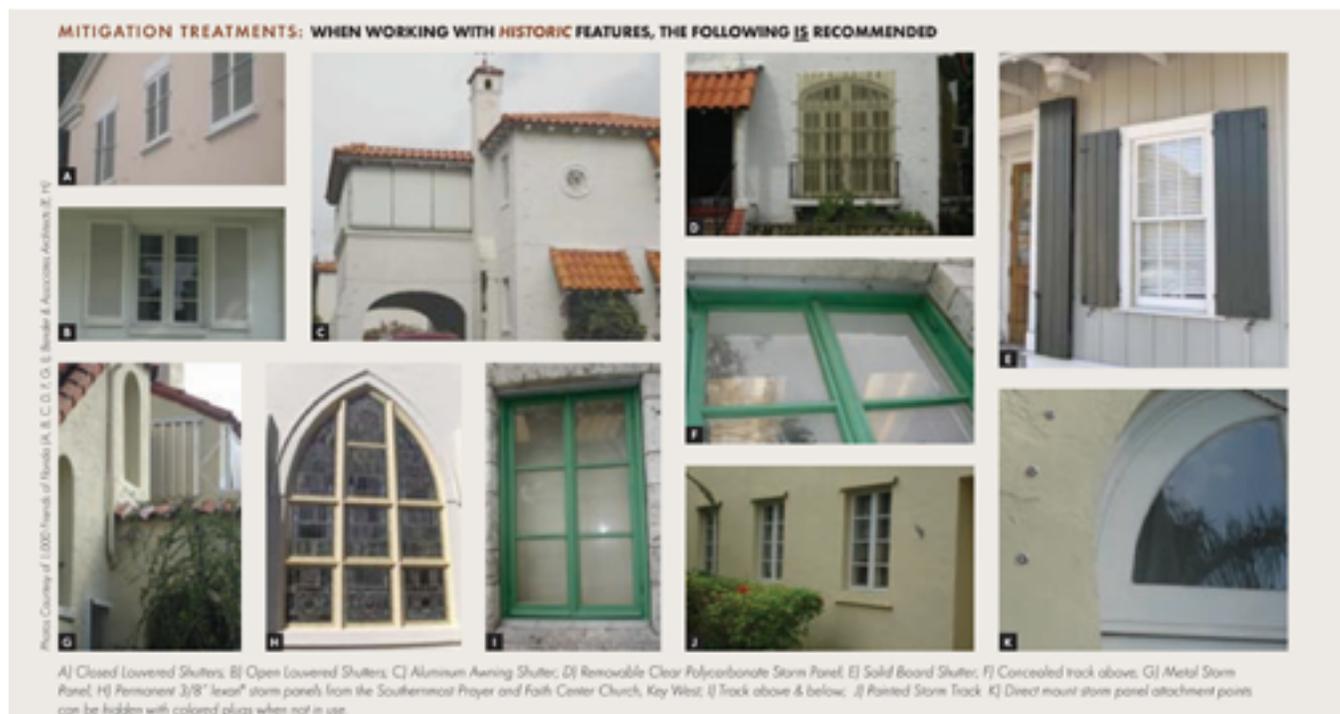
Image below from:  
Disaster Mitigation for Historic  
Structures: Protection Strategies

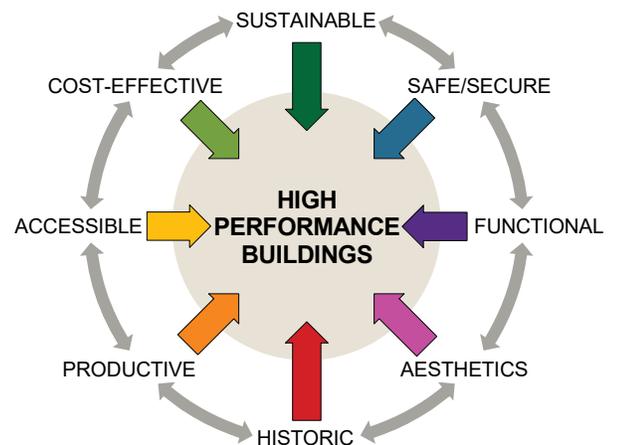
- Safe/Secure - physical protection of occupants and assets from man-made and natural hazards
- Sustainable - environmental performance of building elements and strategies

Diagram based on Whole Building Design Guide's: Integrated Design Approach

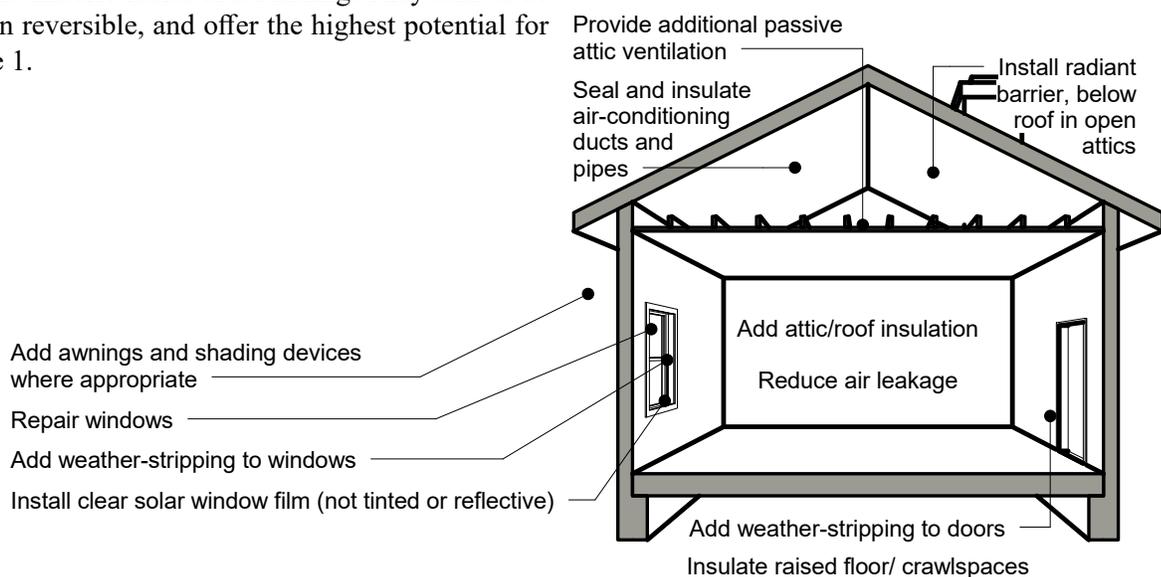
Figure 1

*Requires Minimal Alteration* – Upgrades with the least potential to negatively impact the historic fabric of a building. They tend to be less intrusive, are often reversible, and offer the highest potential for energy savings. Figure 1.

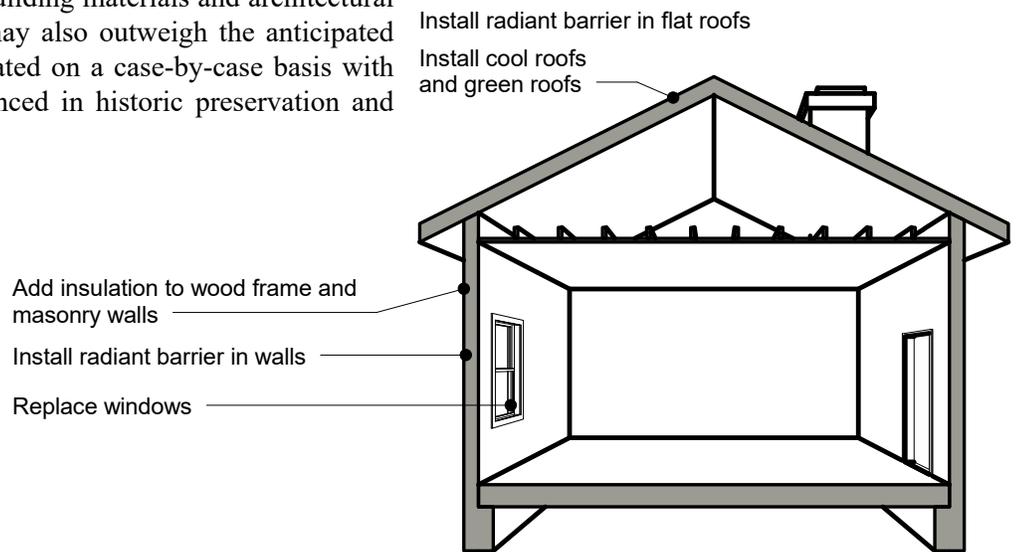
Figure 2

*Requires More Alteration* – Upgrades that may pose technical problems and damage to historic building materials and architectural features. Their installation costs may also outweigh the anticipated energy savings and must be evaluated on a case-by-case basis with advice from professionals experienced in historic preservation and building performance. Figure 2.
