City of St. Augustine

Tree Inventory and Risk Assessment Report

by
Chuck Lippi

City of St. Augustine
Tree Inventory and Risk Assessment Report

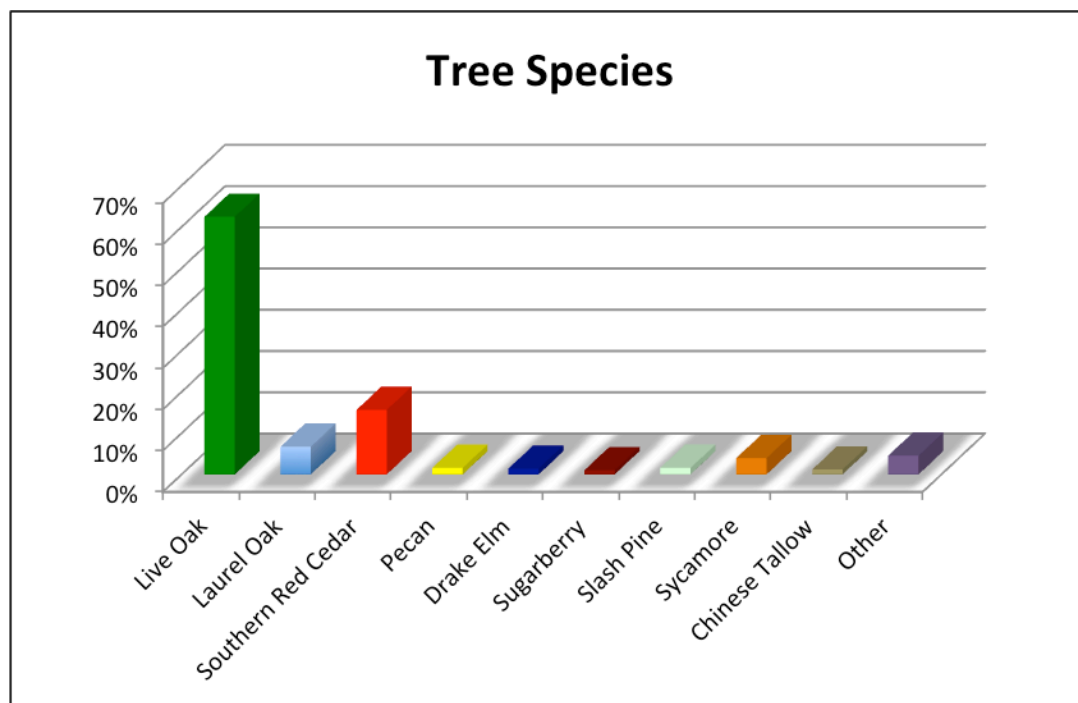
There were 506 trees evaluated in this inventory/risk assessment. In all 20 species of trees were found in the areas surveyed. Figure 1 illustrates the distribution of the major different tree species. Live oaks (*Quercus virginiana*) were by far the predominant species followed by Southern red cedars (*Juniperus silicicola*) and laurel oaks (*Quercus laurifolia*).

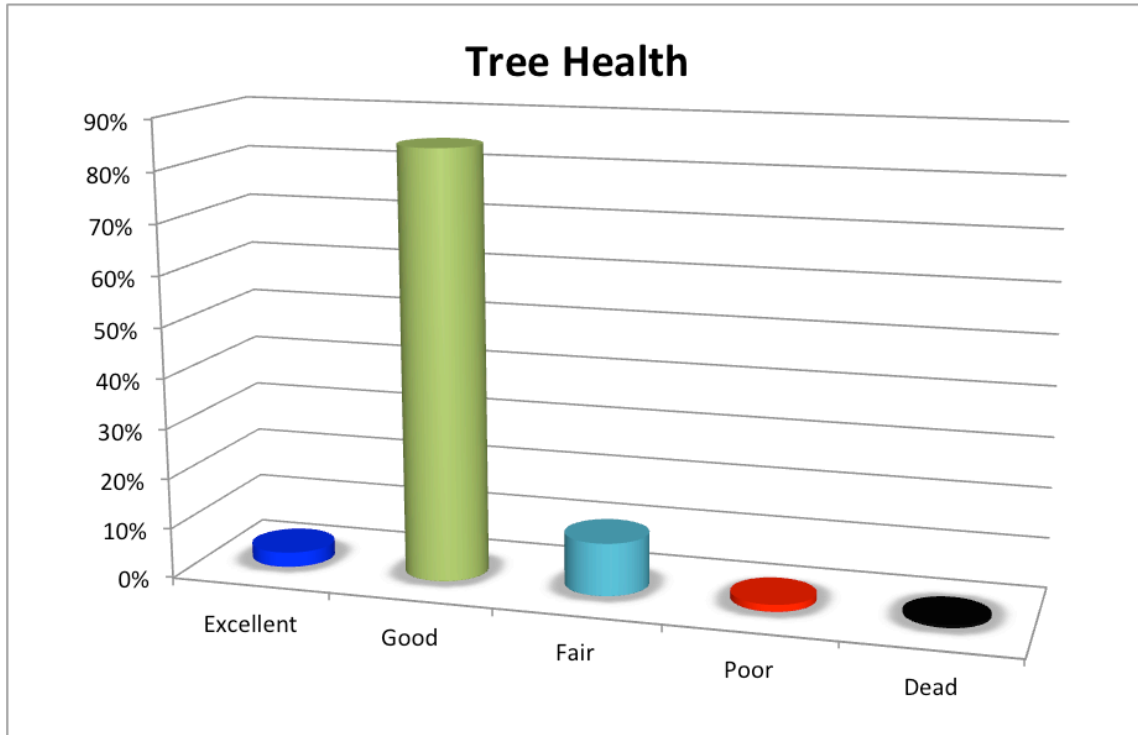
The evaluation of **tree health** classified the trees as having excellent, good, fair, poor, declining and dead. Figure 3 shows the distribution of tree health categories. In general tree health is good for the trees evaluated.

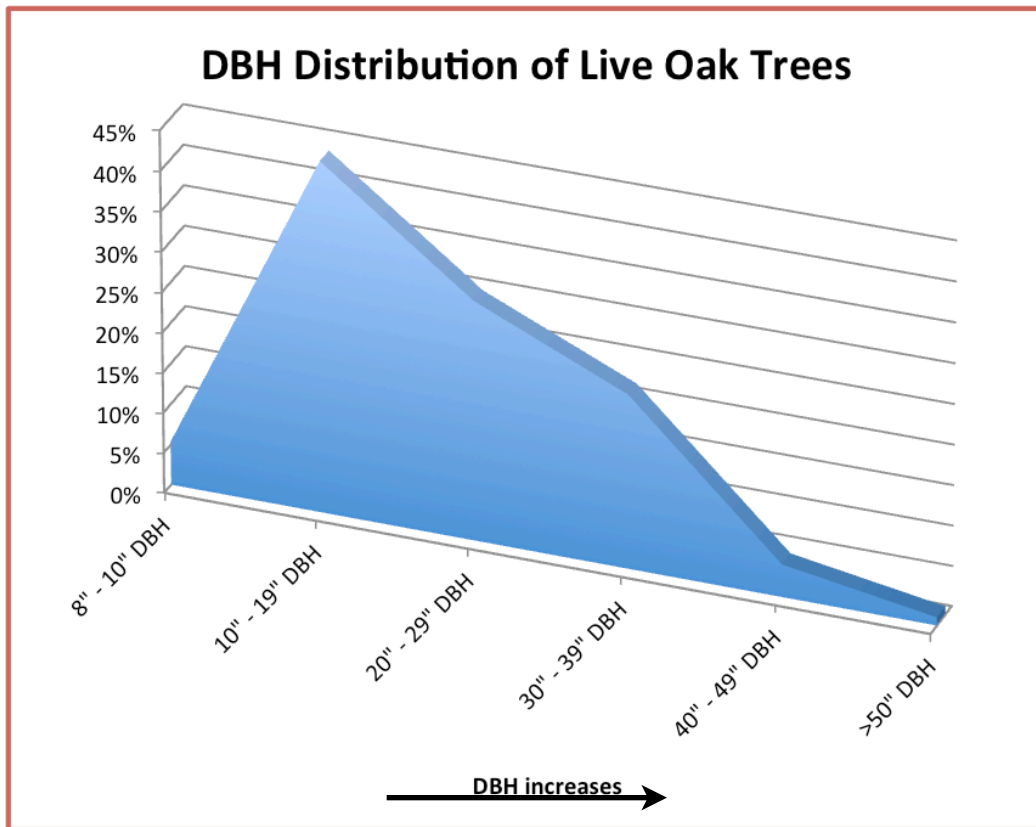
Figure 7

Live Oak Age Distribution -- Because the live oak was the predominant tree found in the survey on the public right-of-way, We analyzed the DBH of the live oak population (Figure 7). We found although there are some very old, large live oaks, the majority of the live oaks have a DBH of 30 inches or less. The majority

of the live oaks are in the 10-inch to 19-inch DBH range which means the parks have a relatively young live oak population. As a rough estimate, live oaks with a DBH of 30 inches could be somewhere in the range of 50 to 100 years old, maybe older.

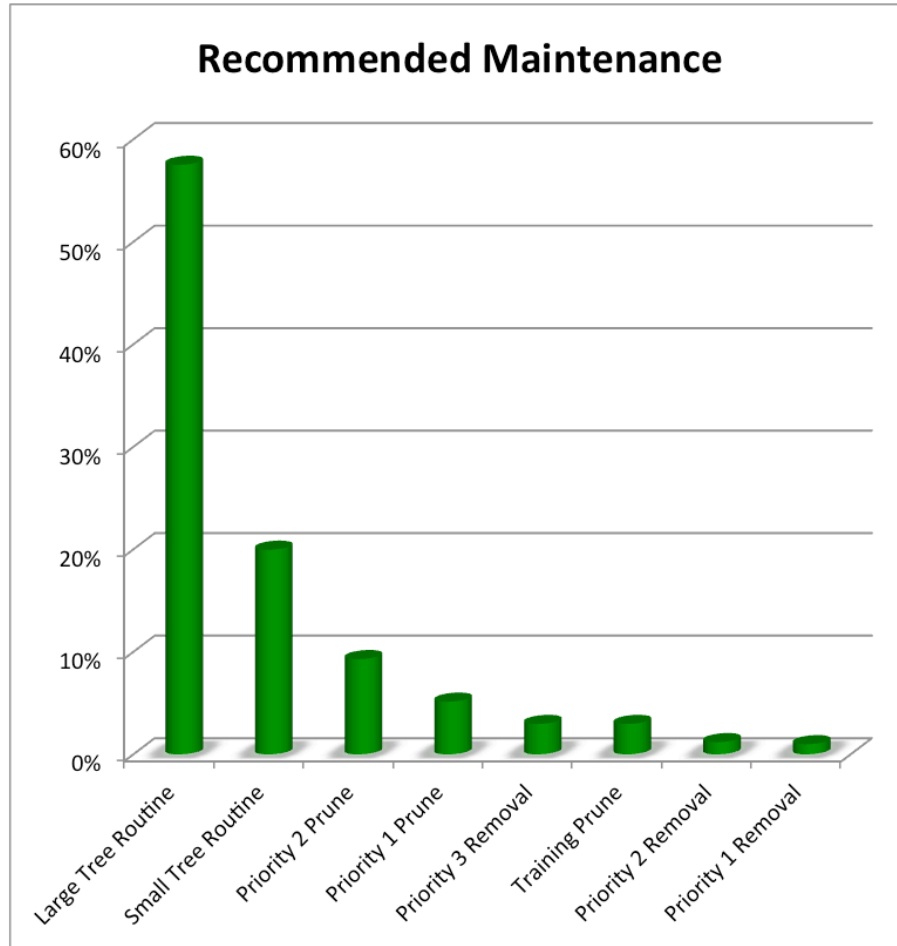
Figure 8

Maintenance -- Maintenance needs and recommendations are shown in Figure 8. Individual tree information is found in the data sheets in Appendix B.

Tree Removal - Only 5 percent of the trees have been recommended for removal (Figure 8) and only 4 trees (three laurel oaks and one red cedar) were given a Priority 1 Removal. The urgency of the removal is dependent upon the risk assessment score corresponding to each tree and their Priority classification. Not all removals have the same urgency. The urgency is determined by the likelihood of failure, size of tree part likely to fail, the target and the tree species.

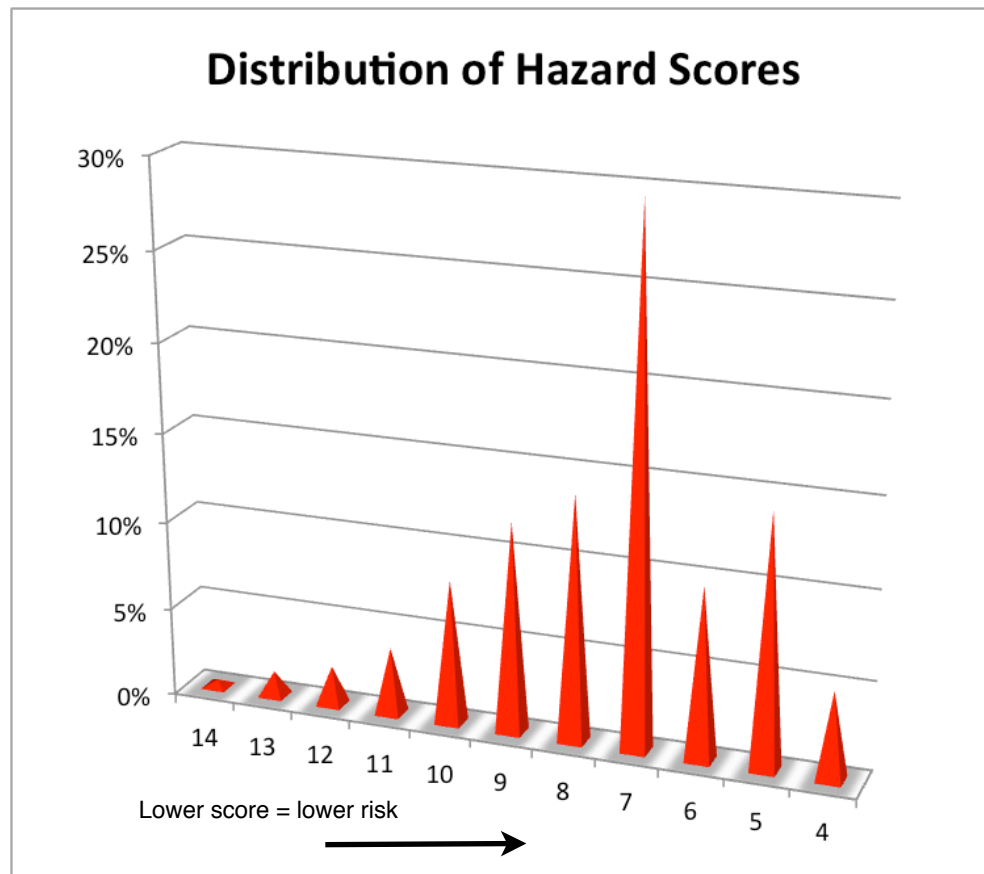
Figure 10

Risk Assessment -- Each tree has a Risk Assessment score based upon the four risk factors -- likelihood of failure, size of tree part likely to fail, target, and tree species. The higher the score, the higher the risk. Scores for trees that are indicated for additional testing are subject to change based upon the subsequent testing results. The distribution of the Risk Assessment scores is shown in Figure 10.
